LAWRENCE
LIVERMORE
NATIONAL
LABORATORY

LLNL-TR-648143

A Visual Description of the Concrete Exterior of the Cactus Crater Containment Structure

October 2013

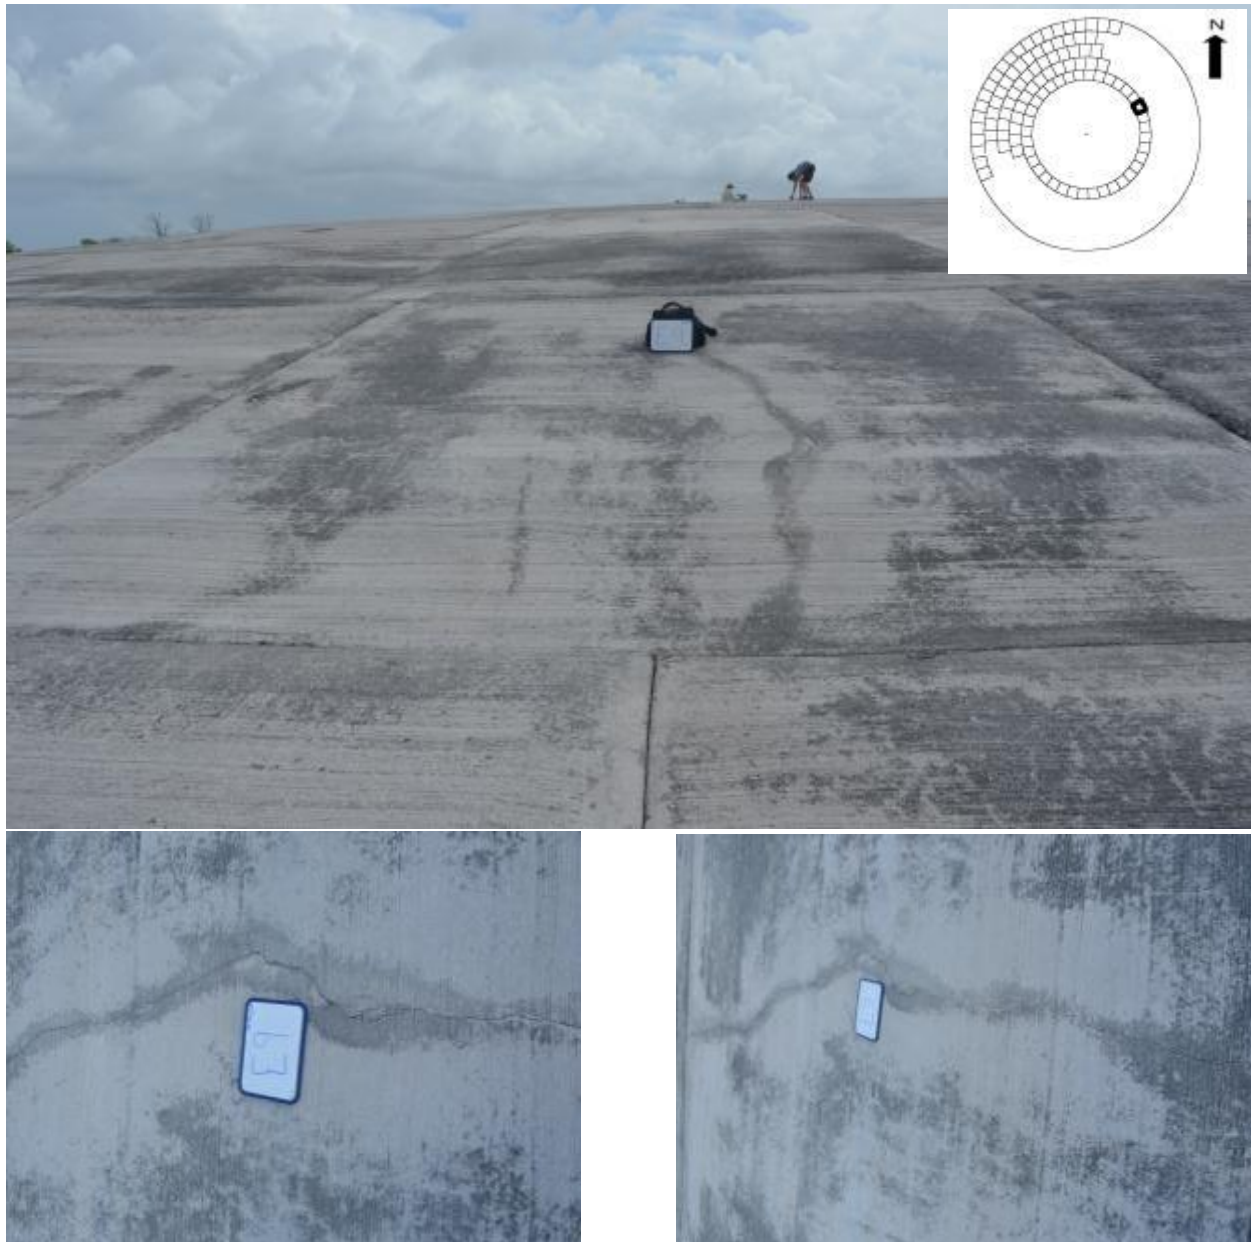
CAP SECTION LOCATION: Panel E9

There is a distinguishable crack running up through the middle of the panel. The crack contains chipped “spalled” edges. Panel recommended for priority repair!

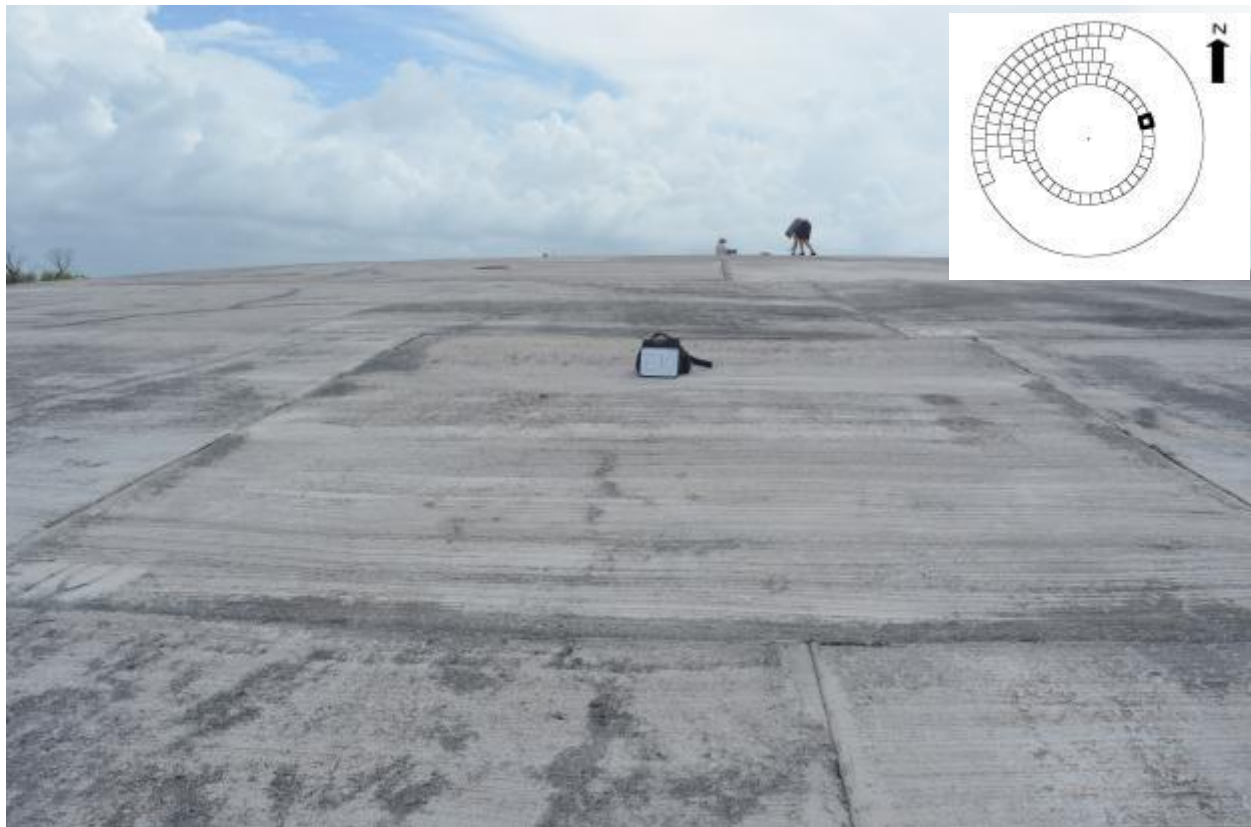
CAP SECTION LOCATION: Panel E10

No significant or obvious interior cracks extending across the top of the panel. Panel has a rough and weathered appearance. Some spalling/cracking of concrete observed in the upper right-hand corner of the panel.

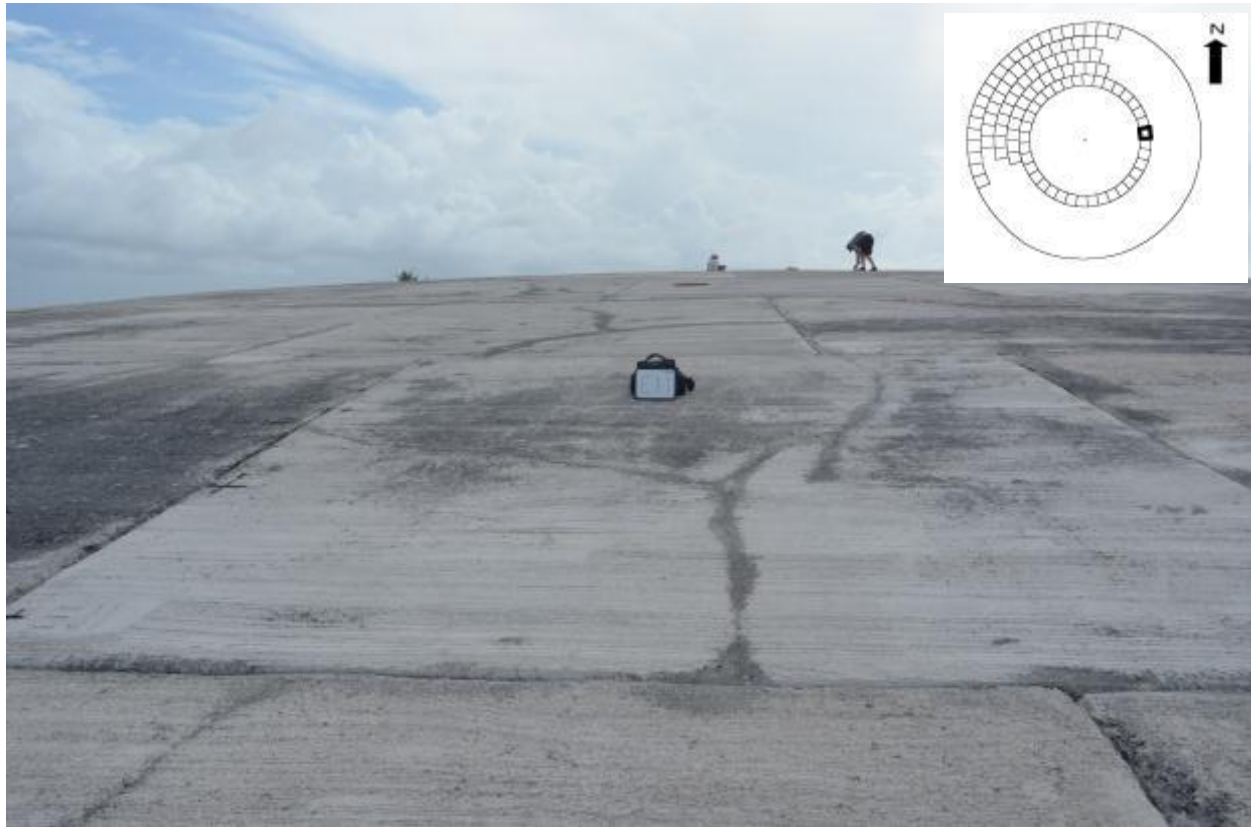
CAP SECTION LOCATION: Panel E11

Some spalling/cracking of concrete observed in the upper left-hand corner of the panel. Surface crack observed traversing up through the middle of the panel splitting off to the left-hand seam and extending to the upper right-hand side of the panel.

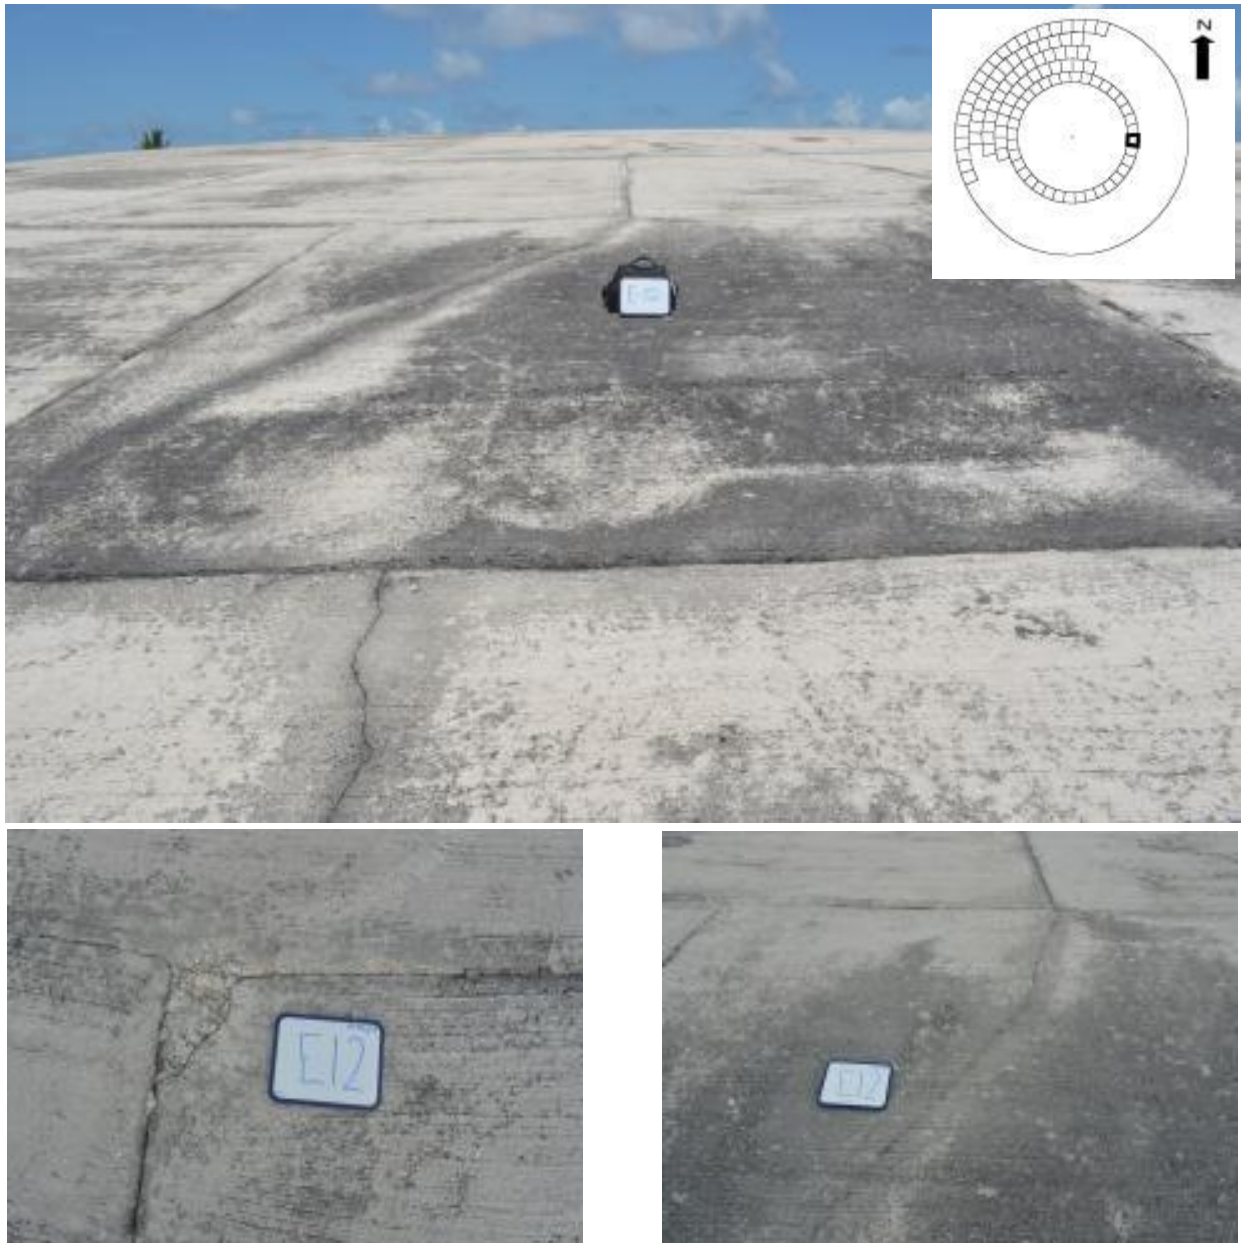
CAP SECTION LOCATION: Panel E12

Panel has a rough and weathered appearance. Significant spalling/cracking of concrete observed in the upper left corner. The panel also contains a distinguishable crack extending up from the bottom left-side of the panel and intersecting the upper seam at a position adjacent to the corner F9/F10 on the ring row above. Panel recommended for priority repair.

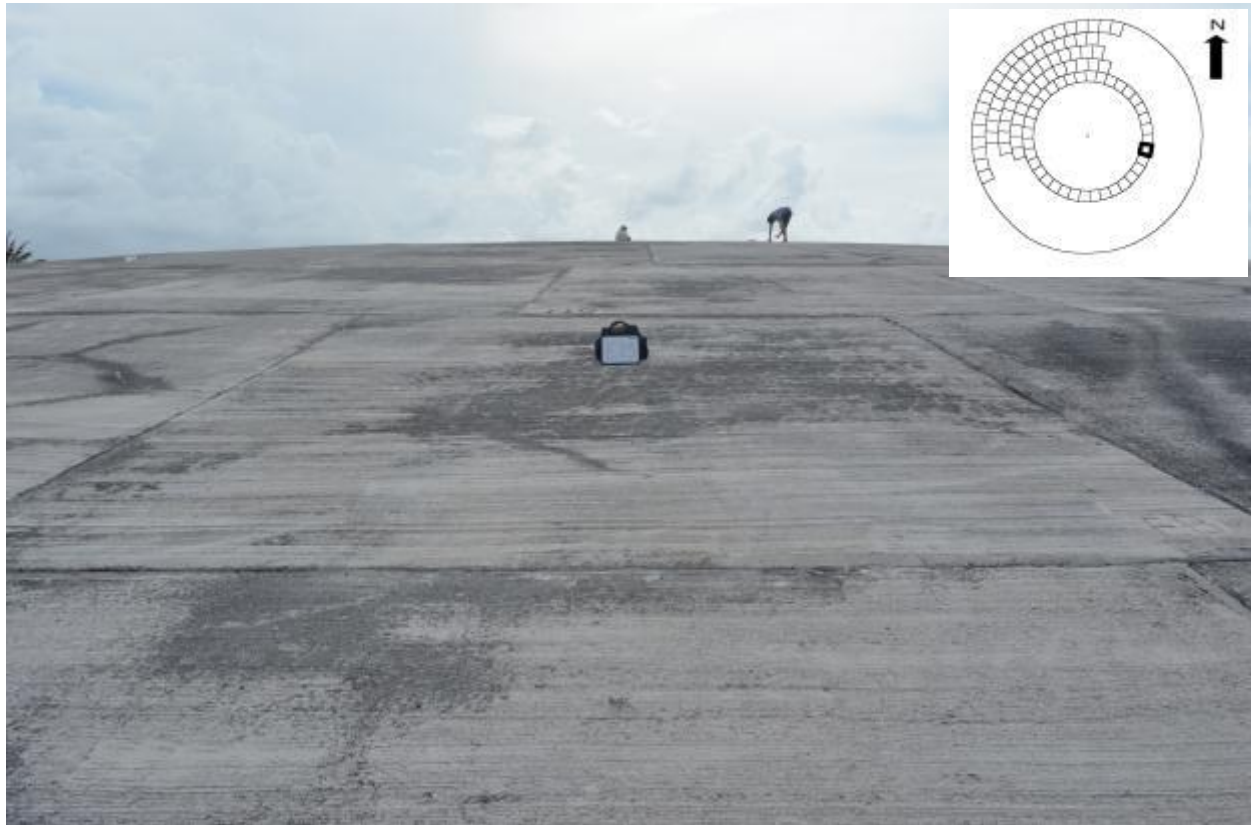
CAP SECTION LOCATION: Panel E13

No significant or obvious interior cracks extending across the top of the panel. Some minor spalling/cracking of concrete observed in the lower left-hand corner of the panel. Panel contains a capped concrete bore-hole (CD-4) from the 1980 NAS investigation.

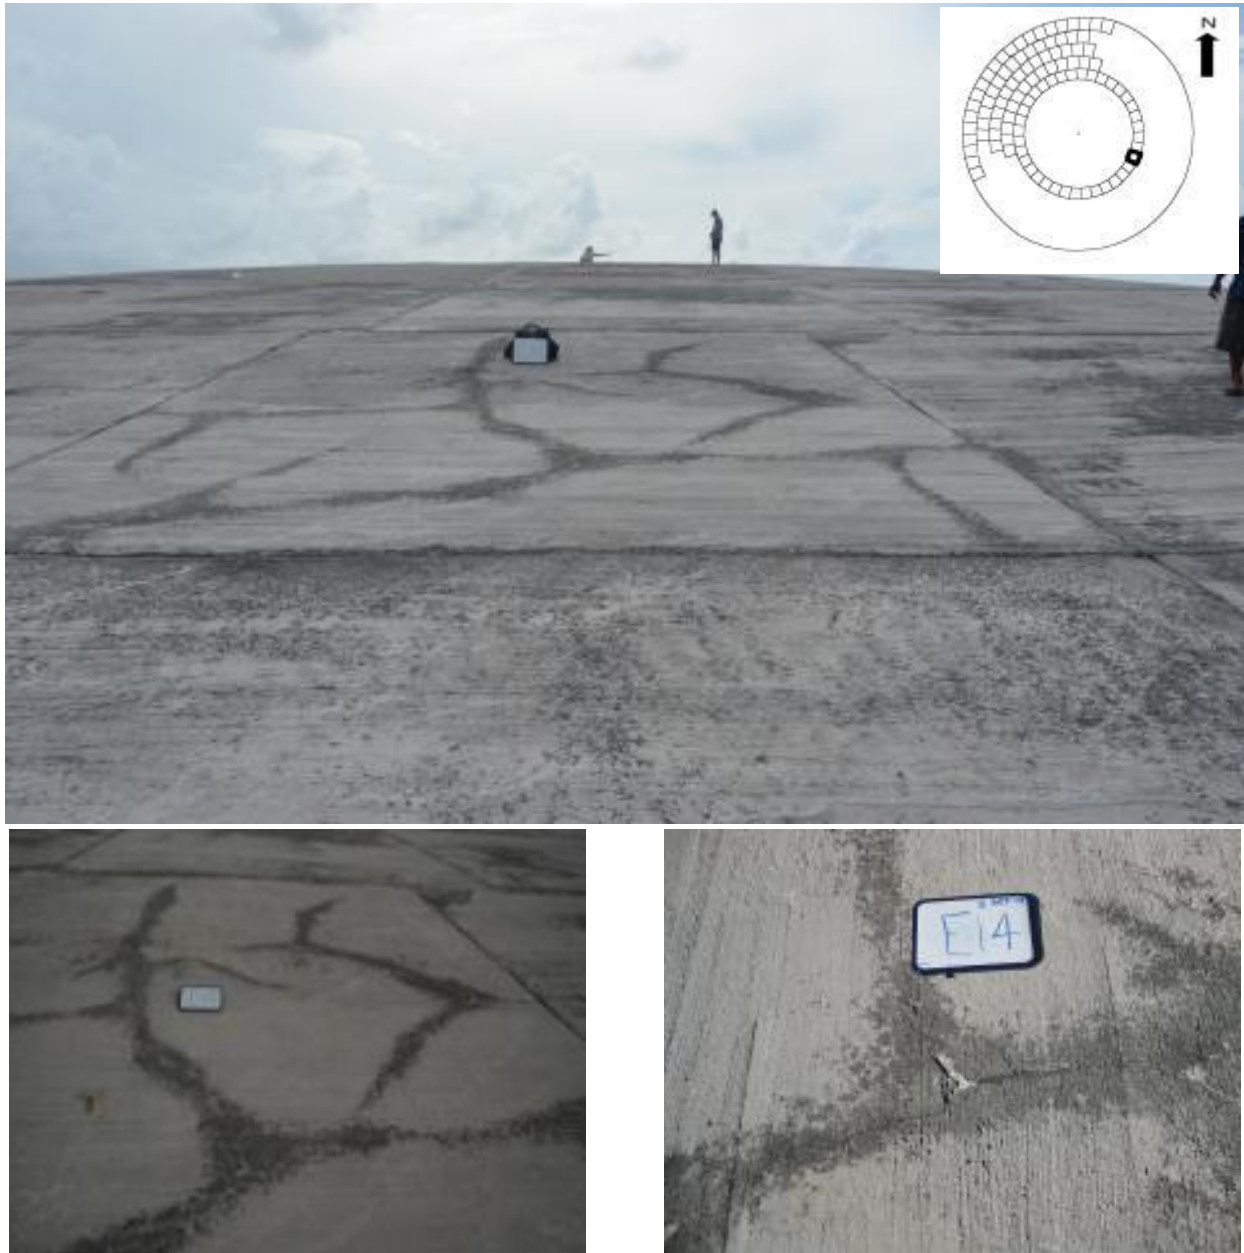
CAP SECTION LOCATION: Panel E14

Some spalling/cracking of concrete observed in the upper left-hand corner of the panel. Numerous cracks appearing in a crisscross pattern extending both up and down, and across the panel (following the shaded lines in the photo – see below).

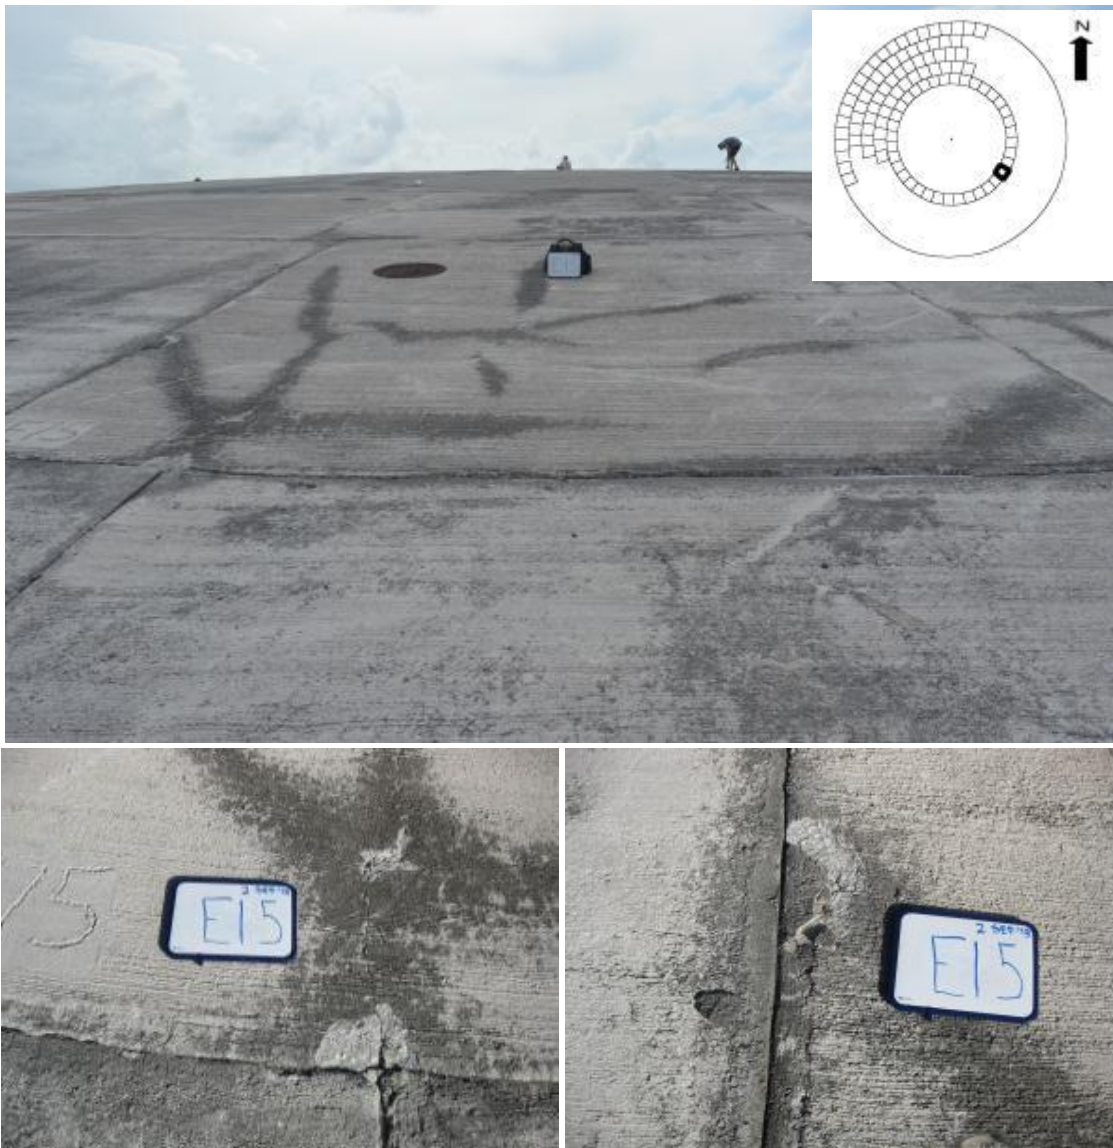
CAP SECTION LOCATION: Panel E15

Significant spalling of concrete observed along the lower seam of the panel, especially adjacent to the intersection corner D18/D19 on the ring row below. A distinguishable crack extends up and across the panel from the same position and intersects the left seam about 2 meters up from the base of the panel. A similar crack occurs across the right-hand corner with other minor cracks forming in a crisscross pattern across the middle of the panel. The panel contains a vertical elevation benchmark. It is recommended that the panel receive priority for repair!

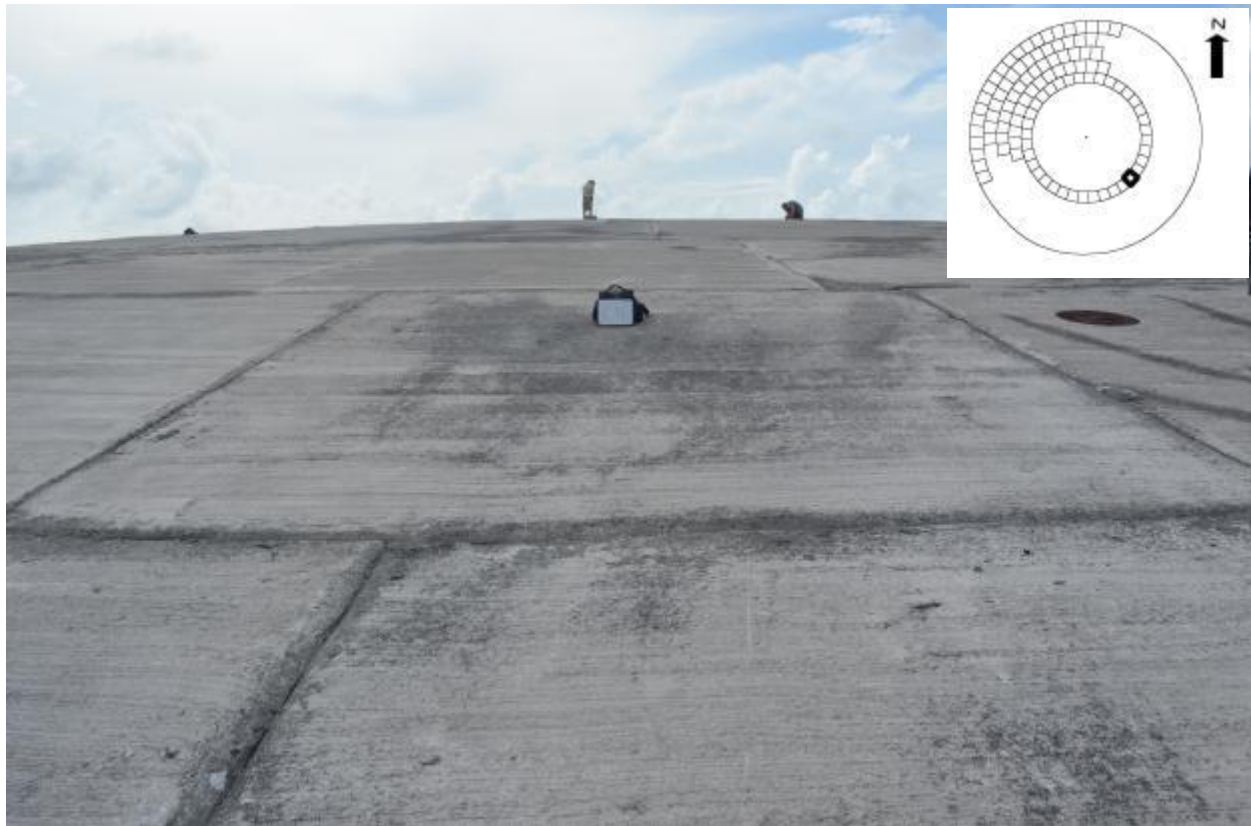
CAP SECTION LOCATION: Panel E16

No significant or obvious interior cracks extending across the top of the panel. The upper portion of the panel has a rough and weathered appearance.

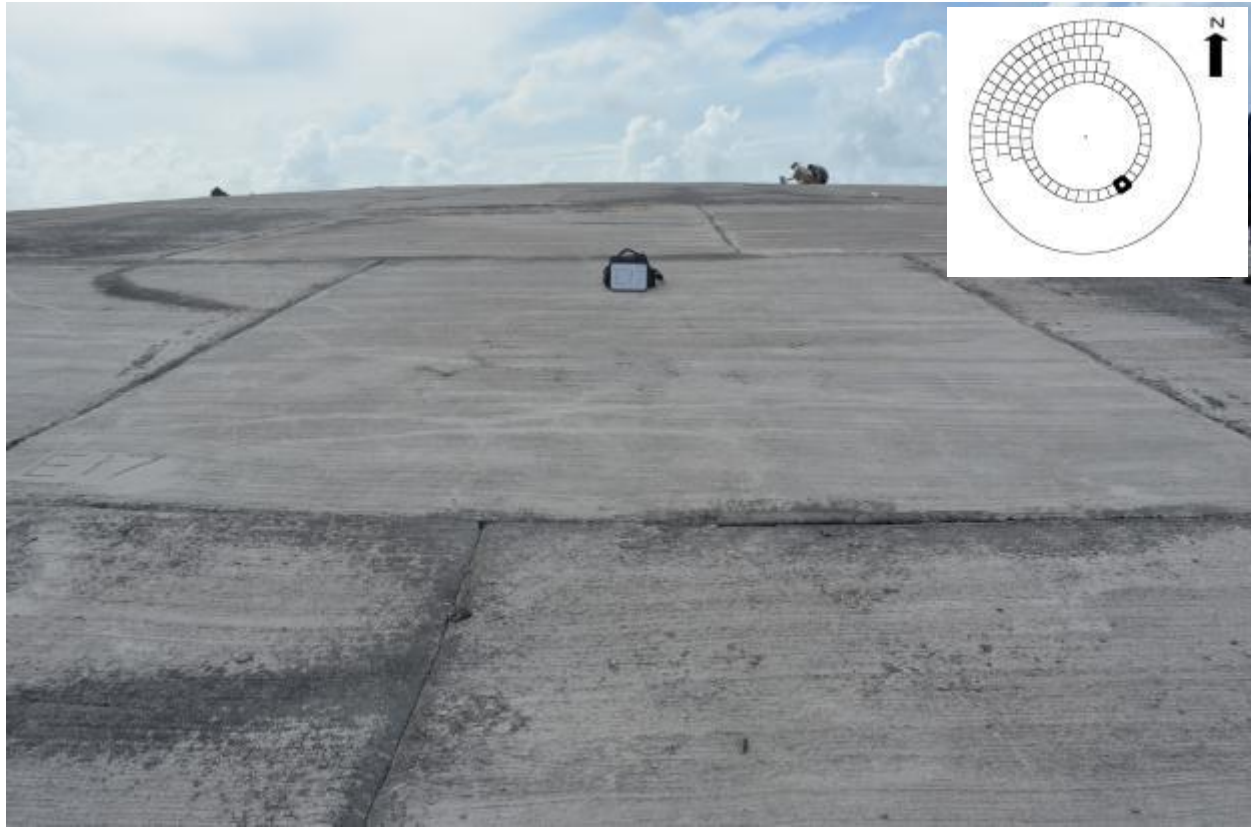
CAP SECTION LOCATION: Panel E17

Significant spalling/chipping of concrete observed along the lower seam of the panel. The panel contains no other significant or obvious spalls or cracks.

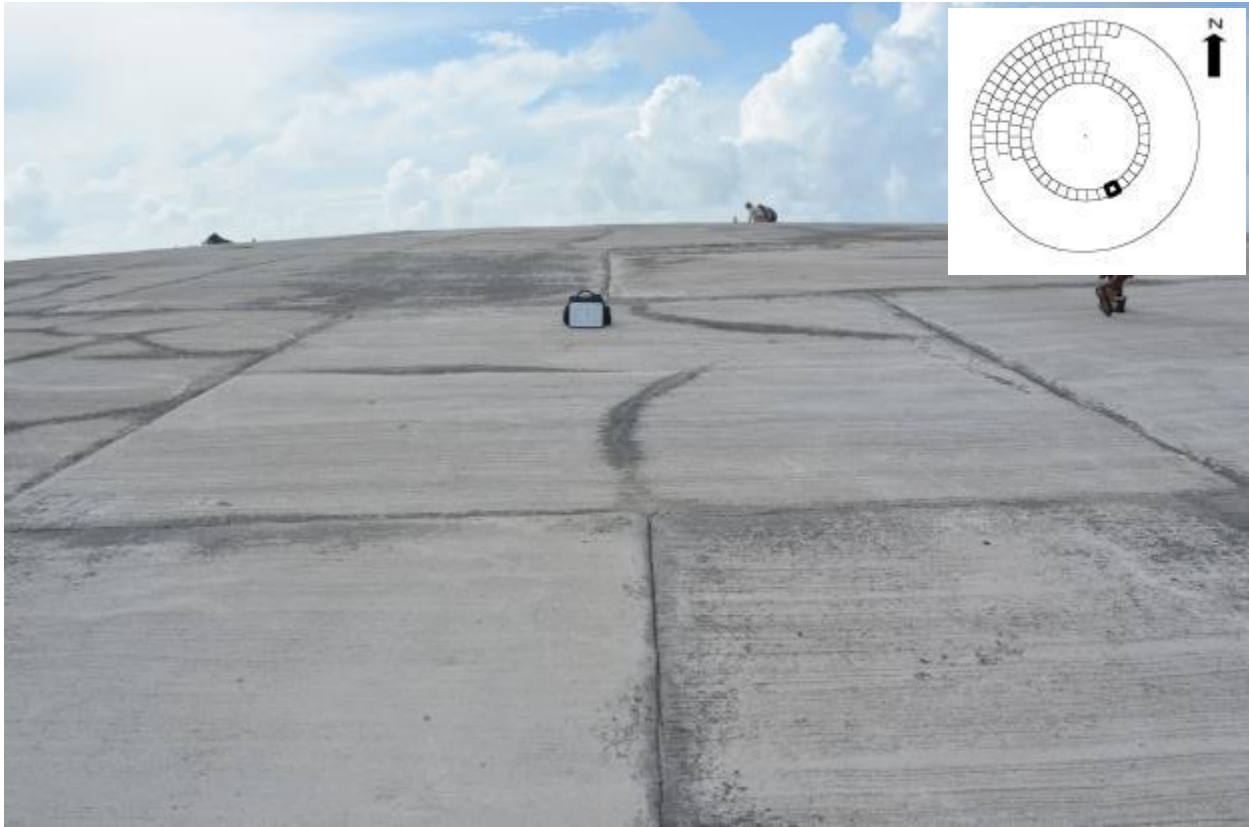
CAP SECTION LOCATION: Panel E18

Some spalling/cracking of concrete observed in the upper right-hand corner of the panel. A surface crack extends up from the base of the panel adjacent to the intersecting corner D23/D24 of the ring row below. A minor crack was observed running parallel with the left seam at a mid-point up the panel.

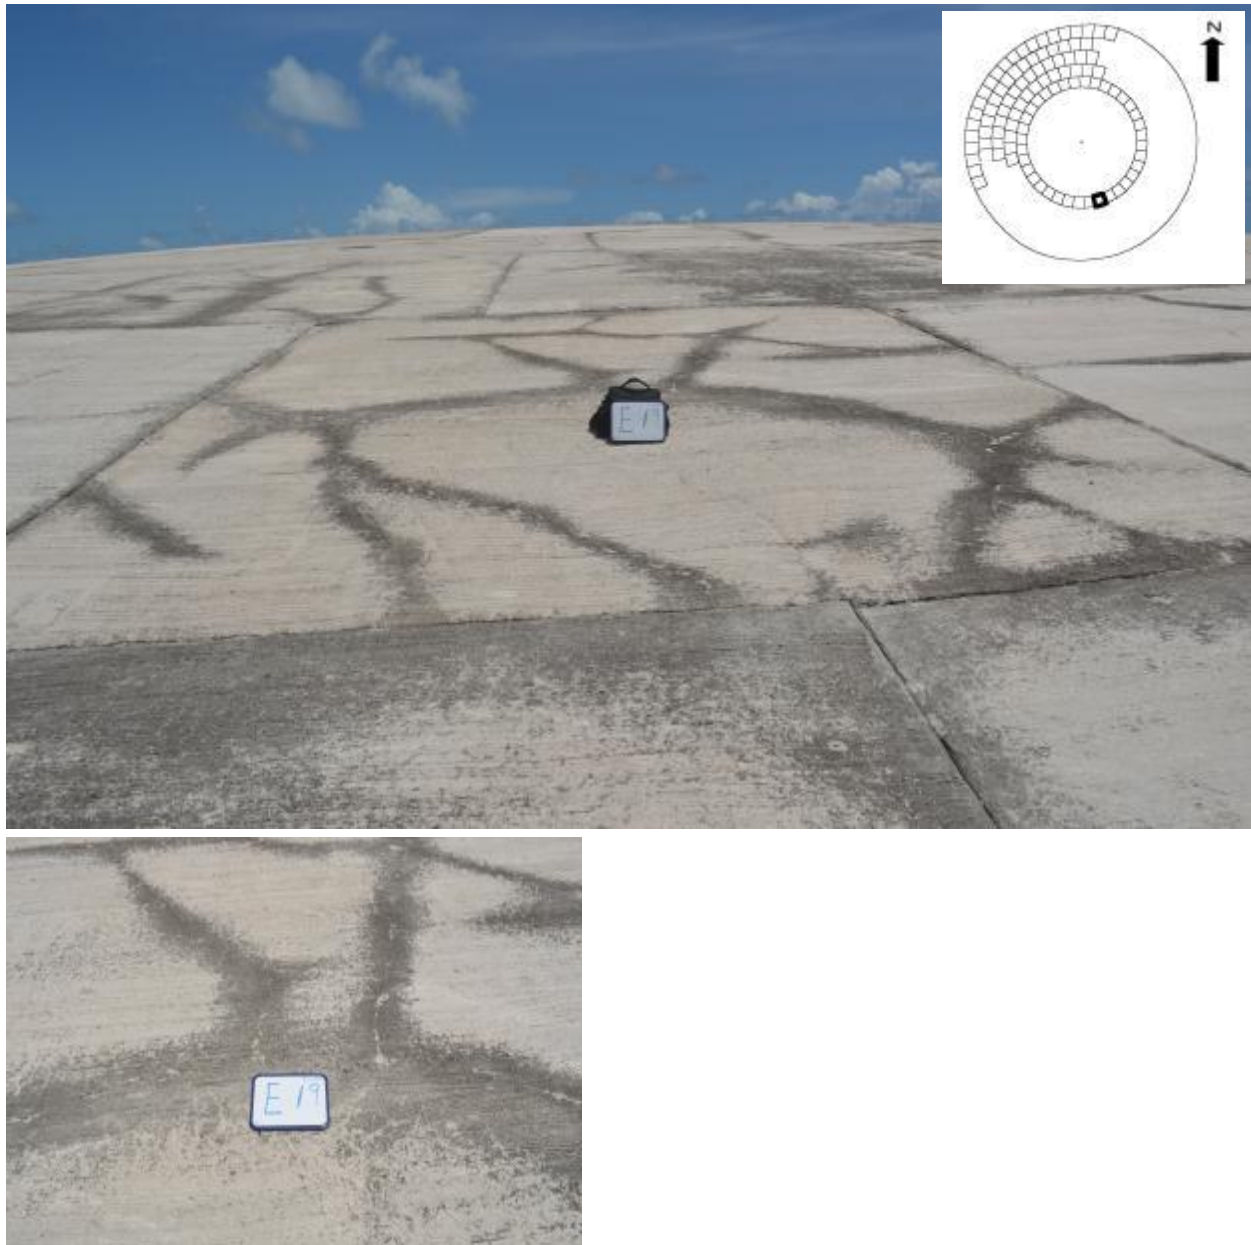
CAP SECTION LOCATION: Panel E19

Numerous surface cracks appearing in crisscross pattern up and down as well as across the panel. Some spalling/cracking of concrete observed in the upper left-hand corner of the panel. Crack lines can be visualized by following the pattern of discoloration in the concrete (refer to photo below)..

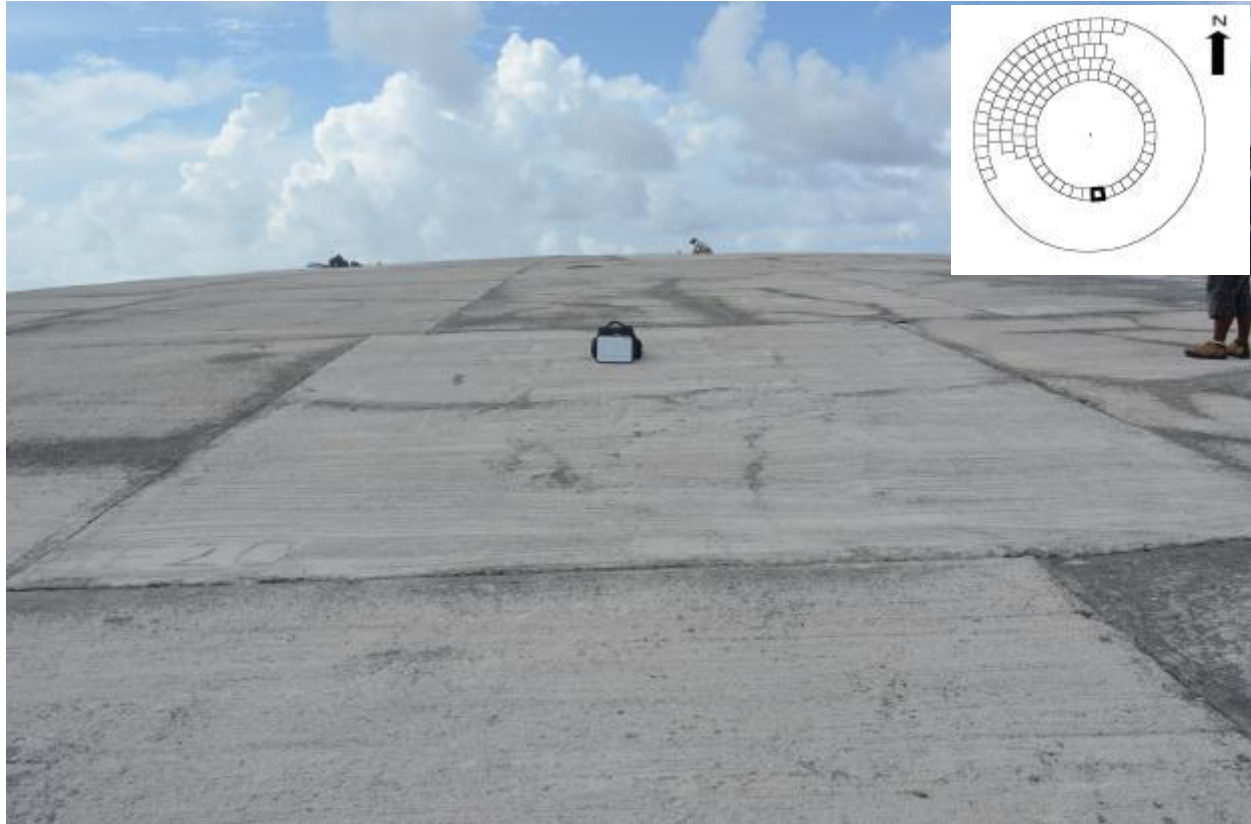
CAP SECTION LOCATION: Panel E20

No significant or obvious interior cracks extending across the top of the panel.

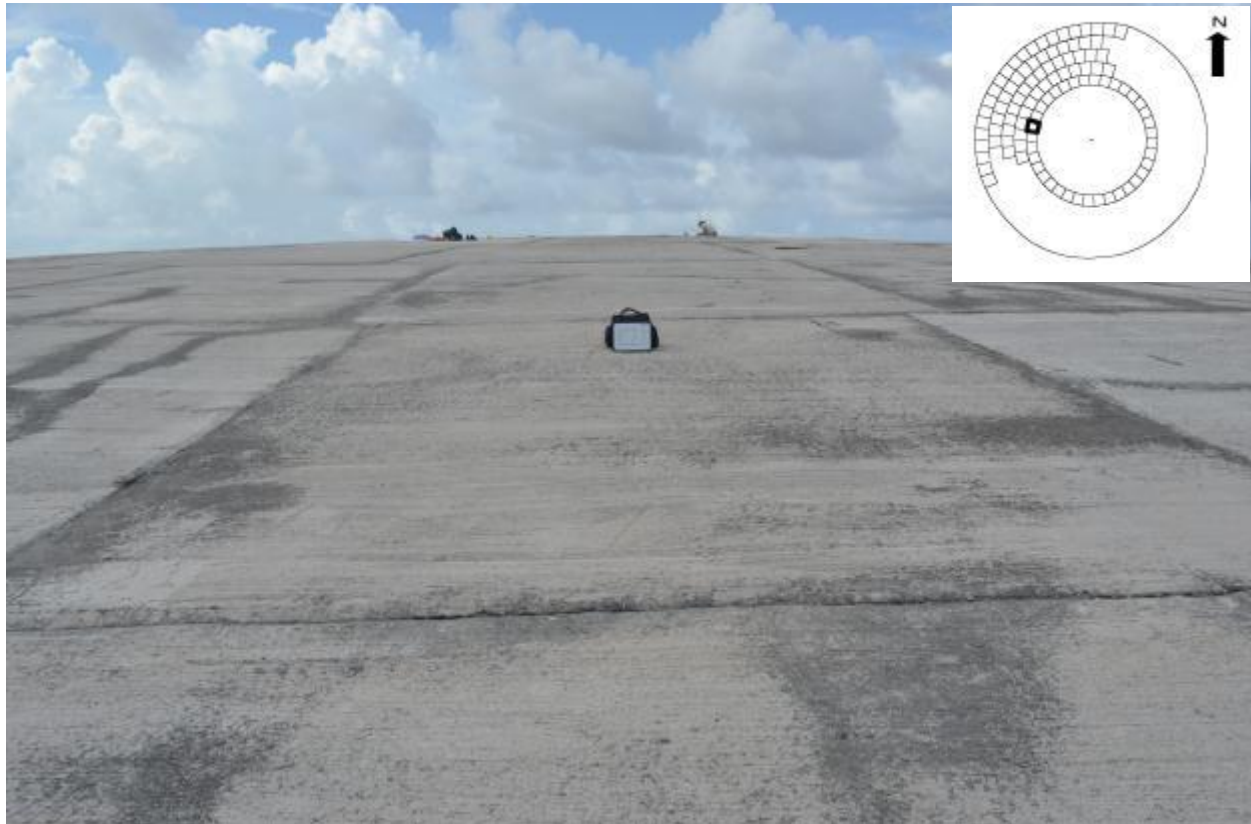
CAP SECTION LOCATION: Panel E21

Some spalling/cracking of concrete observed in the upper left-hand corner of the panel. No obvious interior cracks or spalls extending across the top of the panel with exception of a small voided piece of concrete in the upper right corner (app. 4 x 2-2.5 centimeters in area).

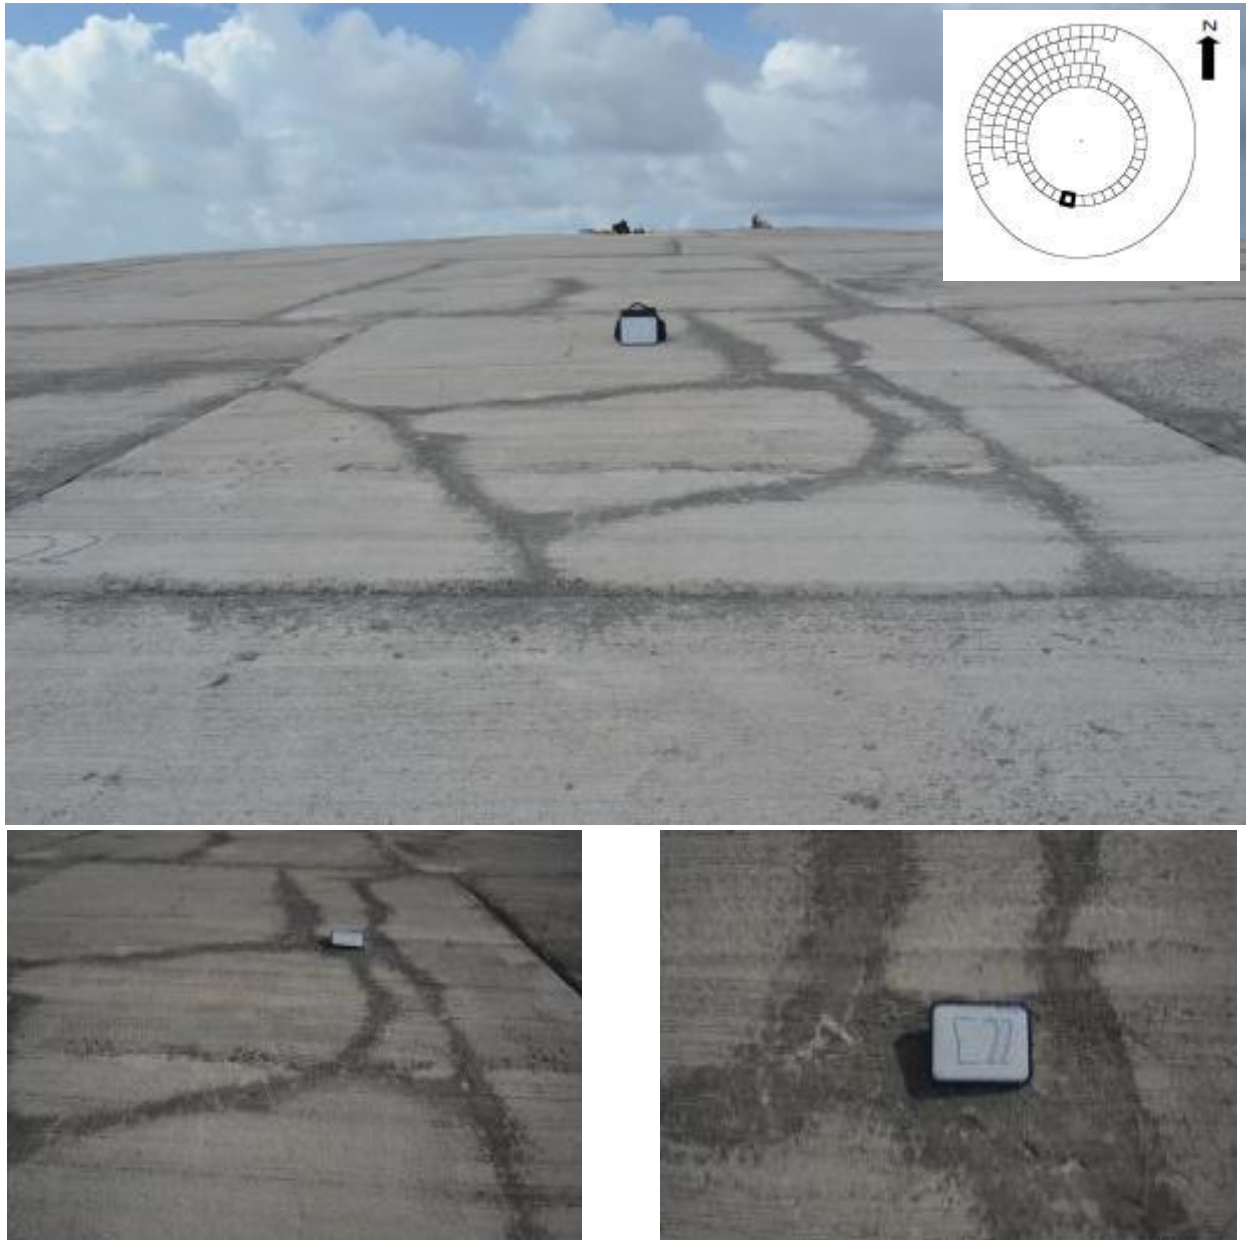
CAP SECTION LOCATION: Panel E22

Some spalling/cracking of concrete observed in the upper right-hand corner of the panel. Numerous cracks were observed extending up and down as well as across the panel (as observed by the shaded areas in the photo below). Panel recommended for priority repair!

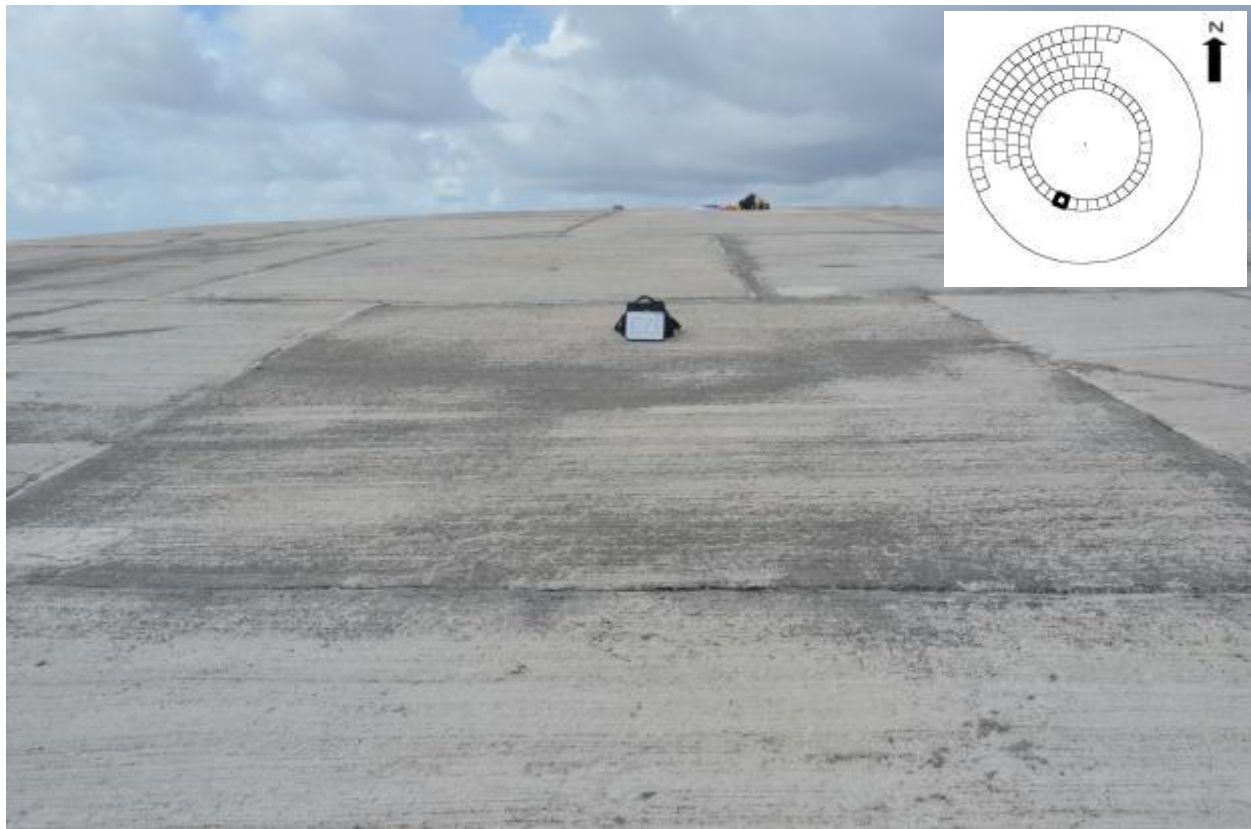
CAP SECTION LOCATION: Panel E23

No significant or obvious interior cracks extending across the top of the panel. Panel has a rough and weathered appearance. Concrete in the upper left-hand corner of the panel appears to be more highly weathered than other areas.

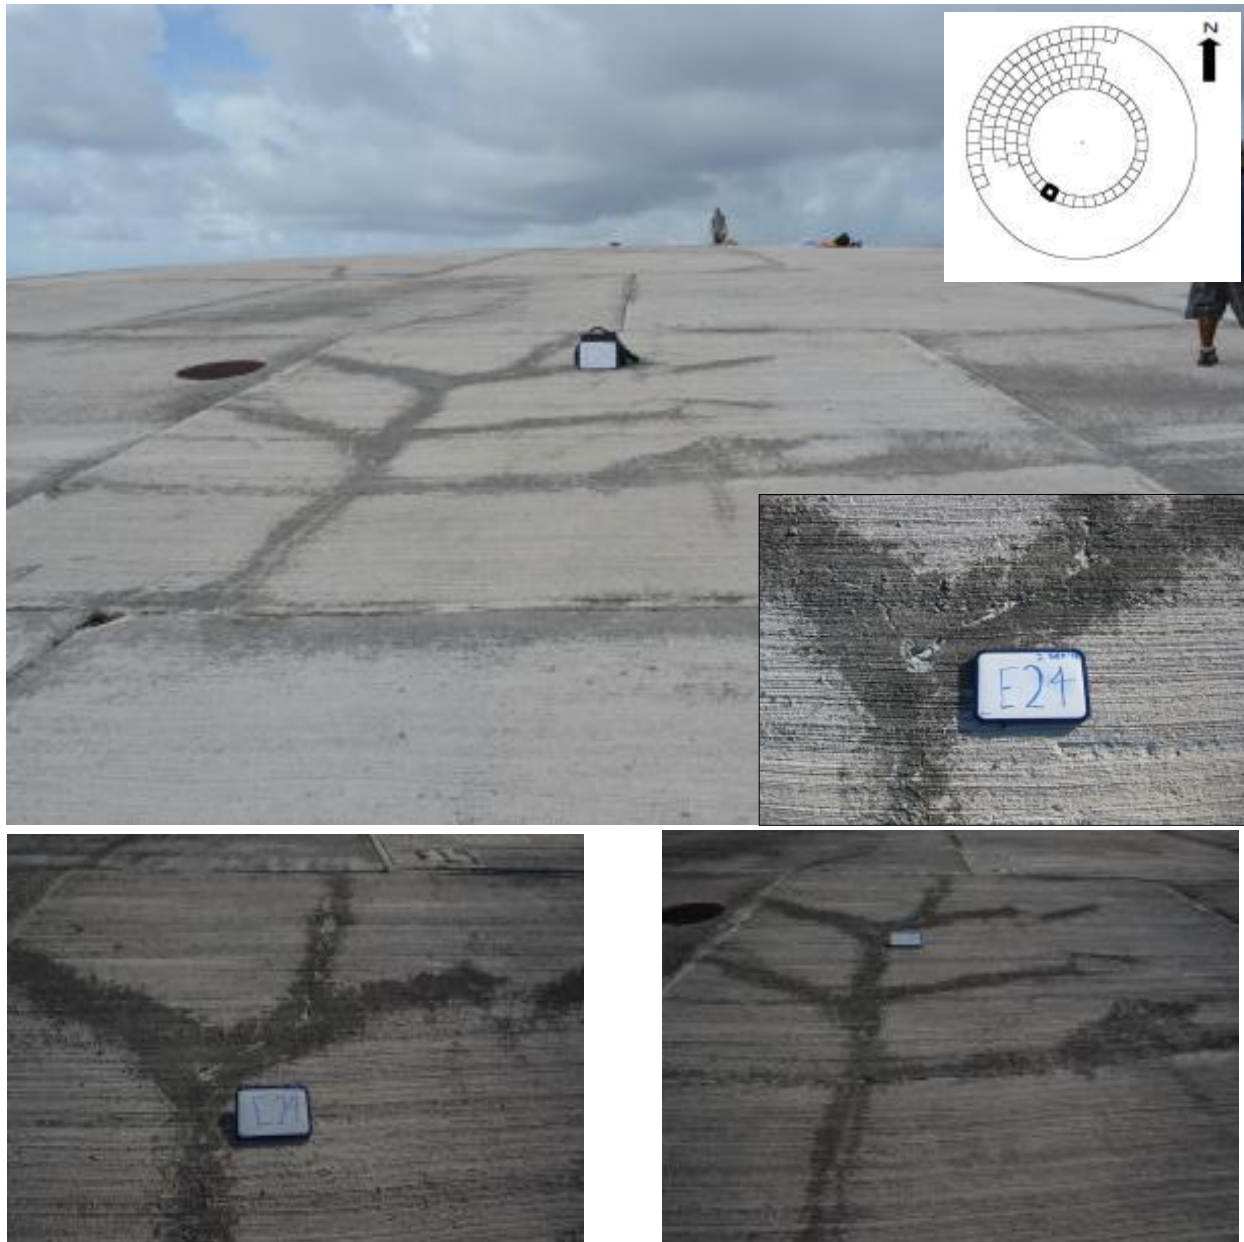
CAP SECTION LOCATION: Panel E24

Some spalling/cracking of concrete observed along the lower left and right seams of the panel. Surface cracks observed crisscrossing up and down as well as across the panel. Most cracks have chipped “spalled” edges and can be visualized by following the pattern of discoloration across the panel (refer to photo below). Panel is recommended for priority repair.

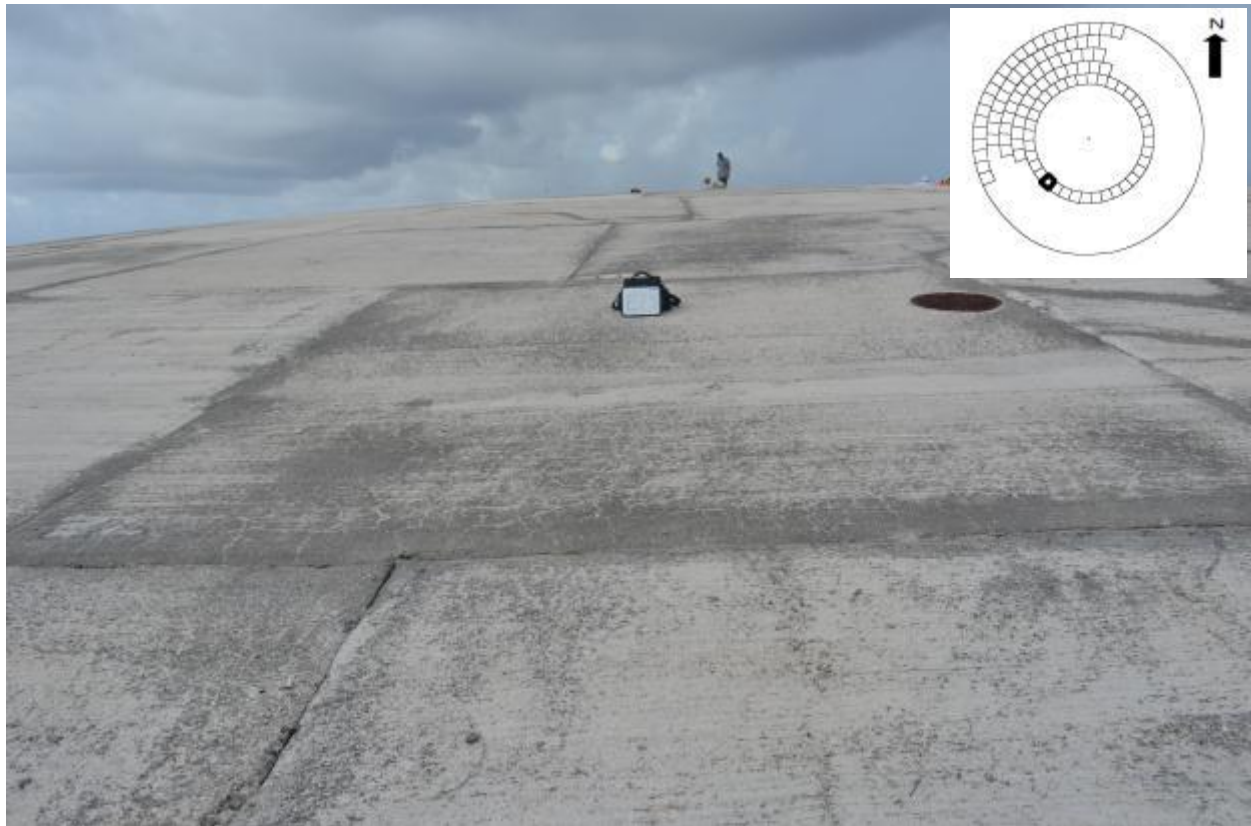
CAP SECTION LOCATION: Panel E25

No significant or obvious interior cracks extending across the top of the panel. Panel has a rough and weathered appearance. Panel contains a vertical elevation benchmark.
